# Manhole Inspection Summary

Manhole # S17SS1003MH

Insp Date: **5/23/07 1:41 PM**

**Location** Address: **CYLBURN AVE**

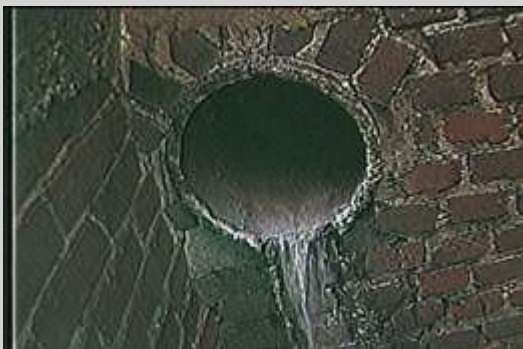
### 10 in. Circular Gravity Sewer Pipe In @ 6 O'Clock

Infiltration: **None** Pipe Seal Cond: **Unknown**

Barrel deterioration and infiltration. Channel deterioration.
